# Ponds filled with challenges

## Water harvesting – experiences in Amhara and Tigray

*Assessment Mission: 30 Sept –13 October 2003*

*By Hugo Rāmi, UN OCHA - Ethiopia*

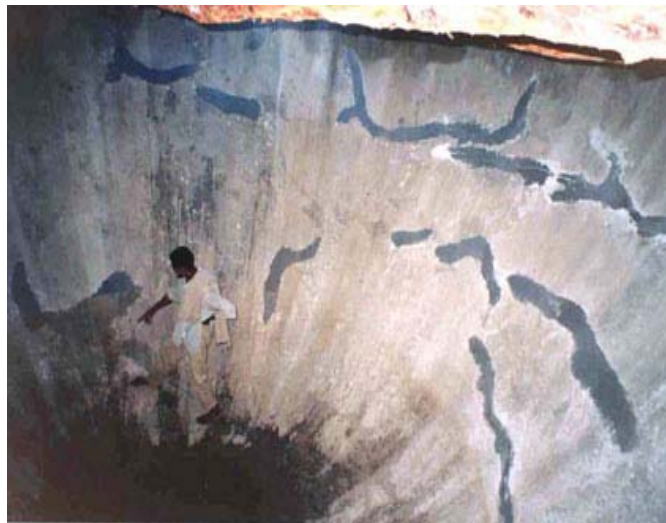
Cracks in the water-harvesting program: 500 water-harvesting experts were trained in Gubalafto, North Wollo (photo H. Rāmi, UN-OCHA, Oct. 2003)

16 structures were built during the course. They are the oldest of their type now in operation in Amhara and give an idea of potential problems with this design. After 10 months of experience of the 16 tanks constructed all but two were leaking heavily. At the end of the good rainy season and a day after heavy downpours, an inspection of several of the structures revealed that none of them contained more than a foot of water. According to the beneficiary farmers, they were never full during the entire rainy season. Silt marks confirmed this. The tanks bore numerous wide cracks at different levels on the walls of the structures (*photo page 1*).

Some farmers have tried to patch the cracks with cement, without success. The cracks reappeared shortly after. One farmer complained that not only money was wasted on his tank, but also his time. He spent three weeks excavating the four-meter deep hole. Other tank beneficiaries indicated that they would not spend their own money on the structures.

One water conservation expert present during the seminar in Woldya explained that the instructions of the manual were followed. However, the completed tanks still leaked. Materials used were: wire mesh for reinforcement of the tank walls, which are made of several layers of a sand-cement mixture in all about 5 cm thick, and stone-mortar for the flooring. The dome and bottle shaped tanks also used steel bars for reinforcing the tank cover. It seems that the construction-guidelines in the manual contains some major mistakes either in the design of the structure, in the use of materials or both.

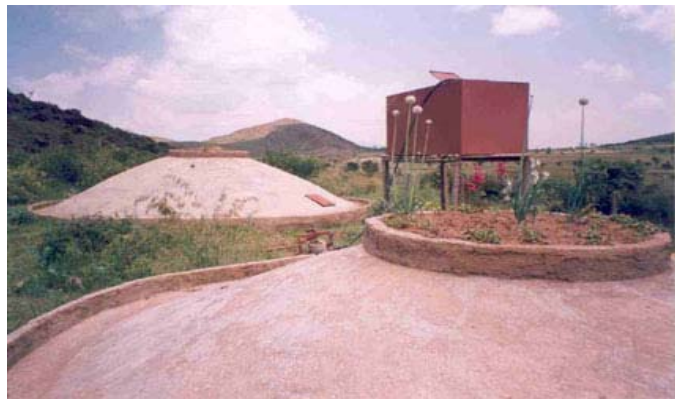
Onions growing on top of dome shaped water-harvesting tank: Trial site in Adama, East Shewa (photo H. Rami, UN-OCHA, Sept 2003)

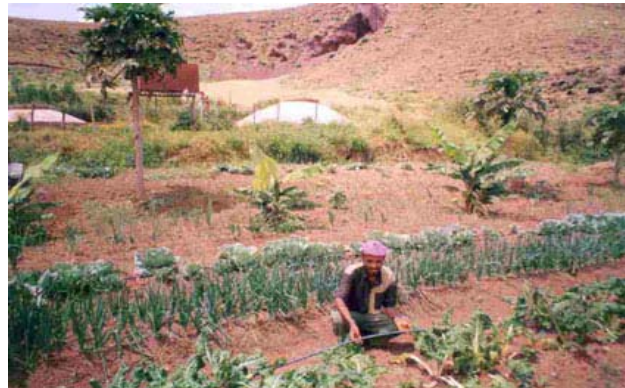
Successful model farmer on the trial site in Adama: Drip irrigation for vegetable production (photo H. Rămi, UN-OCHA, Sept. 2003)

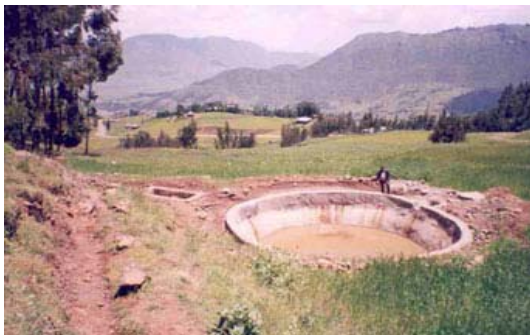
Leaking from outside in: Hemispherical tank built on a slope in Dessie Zuria with groundwater seeping through the walls into the tank (photo H. Rami, UN-OCHA, Oct.

In one site in the highlands near Dessie, the mission witnessed a half empty hemispherical tank built on a slope. On the side facing the valley, with little water pressure from the mountain, the structure was leaking, not from inside out, but from outside in (*photo p. 7*). This is a clear indication that either the structure was built by an inexperienced layman or that the design of the structure itself is too weak. The walls of hemispherical tanks are made of a sand-cement plaster mixed 3:1 but are only five centimetres thick, which seems insufficient to withhold the pressure of 60m<sup>3</sup> of water. Unfortunately the BoA did not consult a structural engineer when the manual was produced.

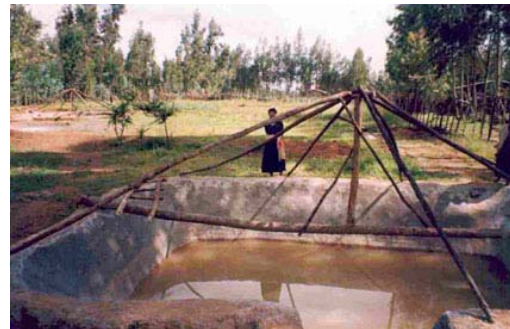
Never filled up: Tank built for poor women's cooperative in an area without water catchment (photo Rami, UN-OCHA, Oct. 2003).

In another site, a cooperative of fifty poor women, growing vegetables with the support of an NGO, benefited from the provision of two large concrete tanks, one hemispherical, the other rectangular. The hemispherical tank was found to be leaking through a large crack where stone-mortar from the bottom joins sand-cement plaster walls. In consultation with his manual, the mason combined two different construction techniques because the underground was not uniform - silty loam at the top and black cotton soil at the bottom. The major problem though is a lack of water runoff. The tanks are built in a totally flat area away from any

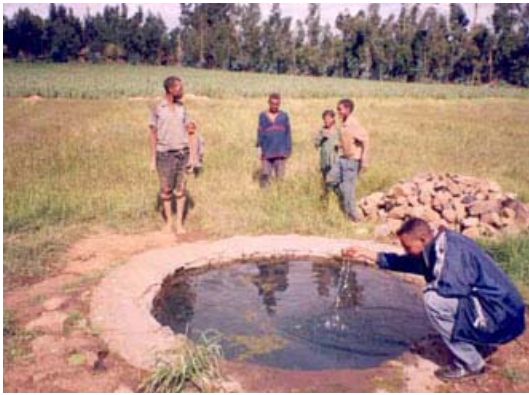
Overflowing: Shallow well built in Meket nearby roof-water harvesting tanks (photo H. Rami, UN-OCHA, Oct. 2003)

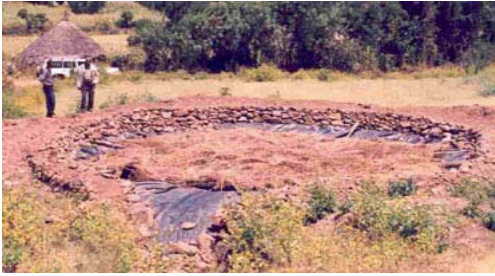
Lack of materials: Plastic lining instead of concrete in hemispherical excavation (photo H. Rami, Oct 03)

Due to previous negative experiences with concrete structures, the BoA officials now want to reshape the more than 15,000 remaining hemispherical holes into trapezoidal ponds that will be lined with plastic membranes rather than using a concrete lining. This carries the danger that the structures are less stable.

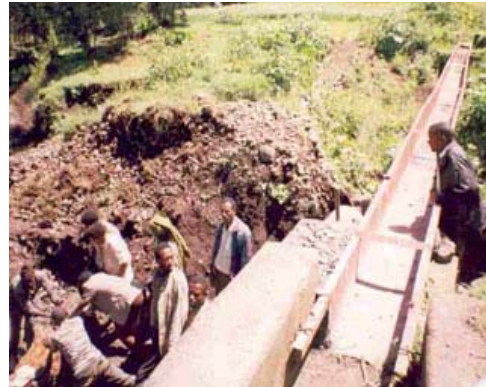
15 times more cost effective: Experts prefer river-diversions to tanks and ponds (photo Rāmi, Sept 03)

According to experts from the Offices of Agriculture and Rural Development in Weldya, the structures, plastic and concrete are too costly for the amount of water they produce. They would preferred more irrigation schemes fed by river diversions, which they believe are more sustainable and suitable to their area. The Office of Agriculture in Dessie for example computed that river diversions cost 15,000 ETB per hectare of irrigated land. This is at least 15 times cheaper than irrigation with the use of ponds and tanks.

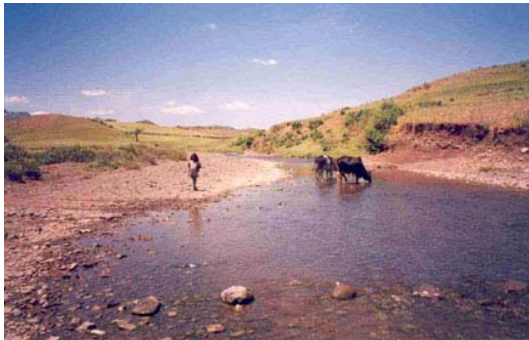
Potential to be exploited: Perennial river running through Ibnat (photo H. Rāmi, UN-OCHA, October 2003)

into hemispherical holes originally intended for cement structures for which no cement was available. Farmers were also not aware of how to repair and seal the membranes. Two ponds built by the woreda office of Agriculture in 2002 dried up quickly last year, when rains were more scarce, raising the question among officials as to the benefit of the tanks in a dry year. A perennial river that runs through parts of Ibnat has good diversion potential, but is only partly utilized (picture left).

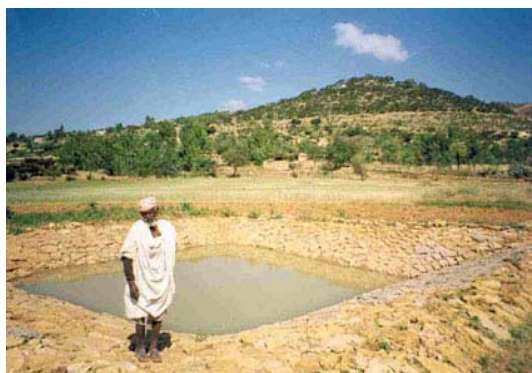
Supplementary irrigation during dry spells: Farmer with his plastic lined pond, covered by stones in Wukro woreda (photo H. Rami, UN-OCHA, Oct. 2003)

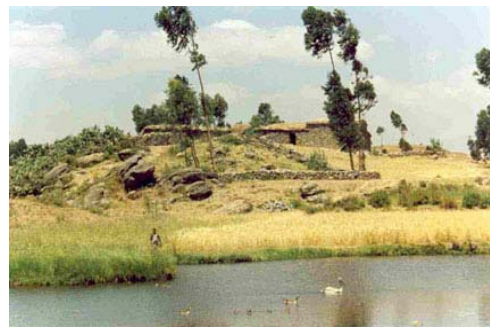
Sustainable and cheap: Community pond in clay soil built during the Derg time (photo H. Rami, UN-OCHA, Oct 02)

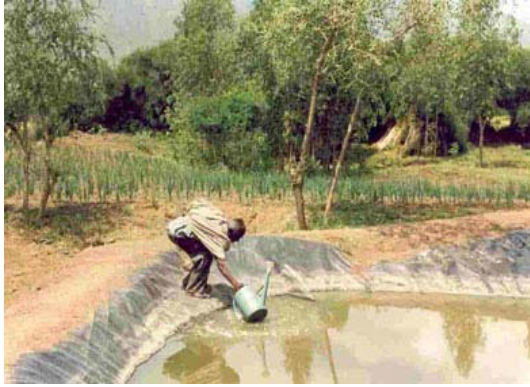
200m<sup>2</sup> of vegetable garden: Farmer fetching water from his plastic lined pond in Alamata woreda (photo H.Rämi, UN-OCHA, Oct. 02)

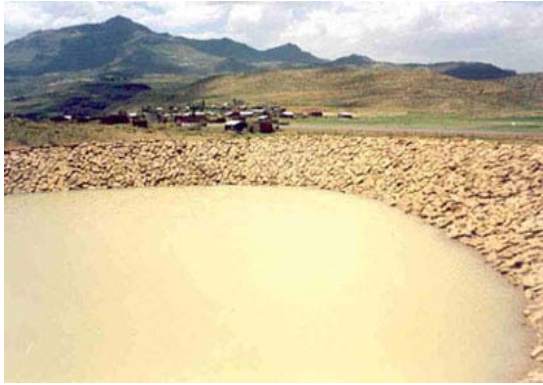
Sustainable: Large clay lined community pond, Dawro Watershed

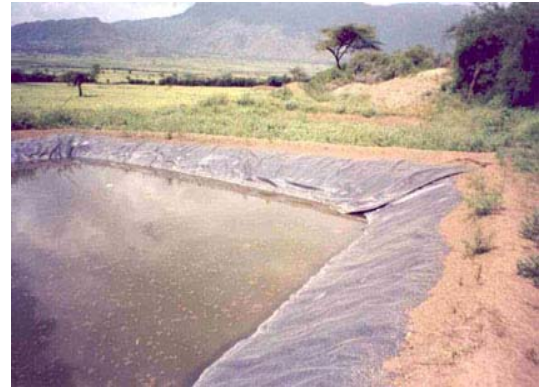
The standard design produced called for plastic-lined ponds with a dimension of 12x12x3 meters and a capacity of 180m<sup>3</sup>. The lining is made of black polyethylene membranes, 0.5 mm thick and treated against the corrosive effects of ultraviolet sunrays. Standard expected life is 10 years. The cost per unit is 1500 ETB, which is less than half the material cost of 60m<sup>3</sup> concrete tanks built in Amhara. The construction of ponds with plastic liners is about 10 times cheaper per cubic meter than that of concrete tanks.

Cheaper than concrete: Plastic lined pond Alamata

While plastic-lined ponds have a good water retention capacity and are relatively cheap, their sustainability is under question. Plastic sheets, once punctured, are difficult to repair and trained personnel, not found in most rural woredas, must weld plastic sheets. The construction guidelines recommend covering the plastic membranes with flat stones once the sheeting is placed into the hole. This however increases the danger of puncture, when people walk on them while gathering water.

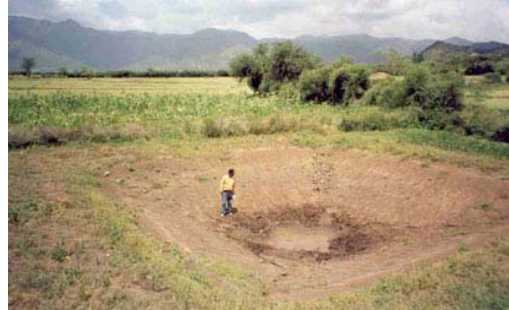
Seeping clay pond, Alamata Woreda (photo Rămi, Oct 03)

Many of the clay-lined ponds were seeping. The major reason was the local soil characteristics, being a silty-sandy loam. The clay layer, which was applied to the pond walls, was often too thin and not properly compacted. Onions planted during the rainy season were doomed to wilt beside the empty clay ponds. However, farmers said that the seeping ponds had a positive effect on lower lying fields, which may have gotten some additional moisture from the seepage into the ground.

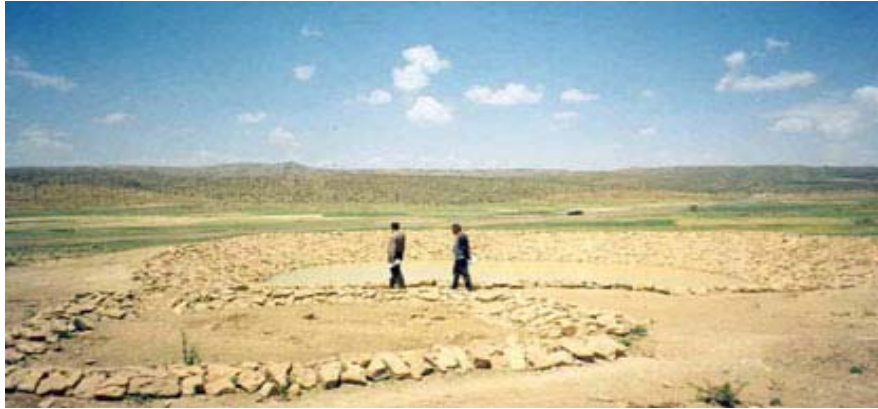
Rapid siltation: Full silt trap due to lack of watershed treatment, Geteb Dawru watershed (photo H.Rämi, UN-OCHA, Oct 03)

- An integrated approach to water harvesting is lacking in most places. Watershed management with reforestation and other erosion control measures is often missing or not adequate where ponds and wells are built. Siltation is a major problem. Integrated extension work concerning health, safety and the proper use of the ponds for agricultural production is mostly lacking.

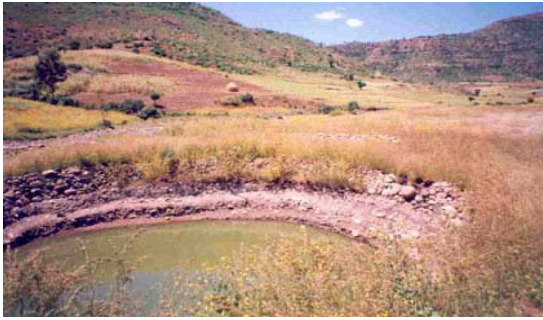
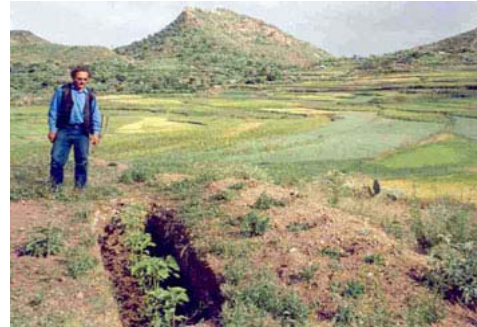
Harvesting the rainwater where it falls: Recharging of ground water in Ibnat Woreda with large unsealed ponds collecting run-off water (left) and trenches planted with sunflower and ground wedge in Tigray (below) (Photos H. Rāmi, UN-OCHA, Oct. 2003)
